Inspection Report Summary

Record 071211-1 - Report, Sample 6 McDermott Place, Brigantine, NJ 08203

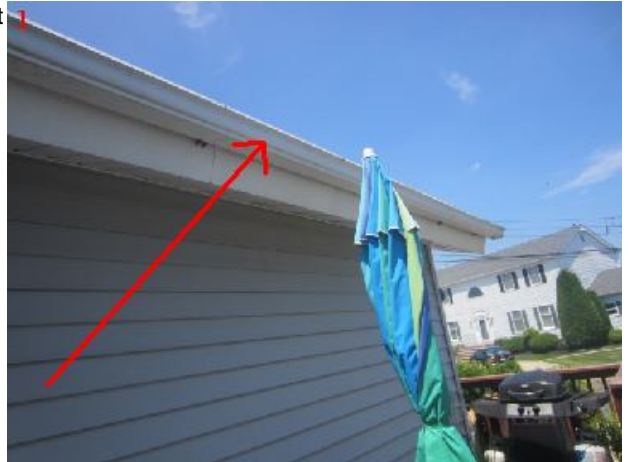
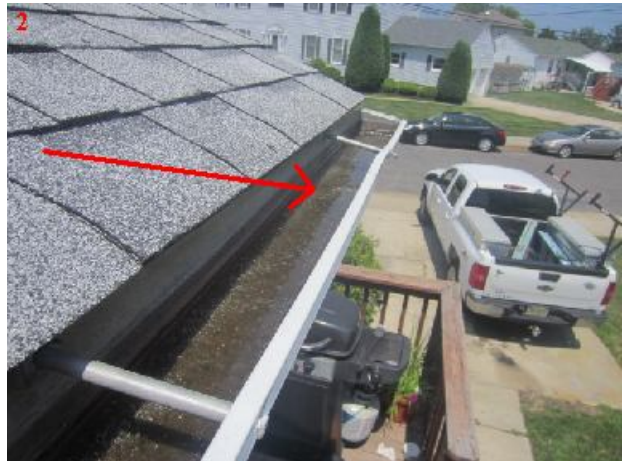
The front left side gutter is improperly pitched and is ponding water at the end of the gutter. We recommend repairs by a gutter professional.

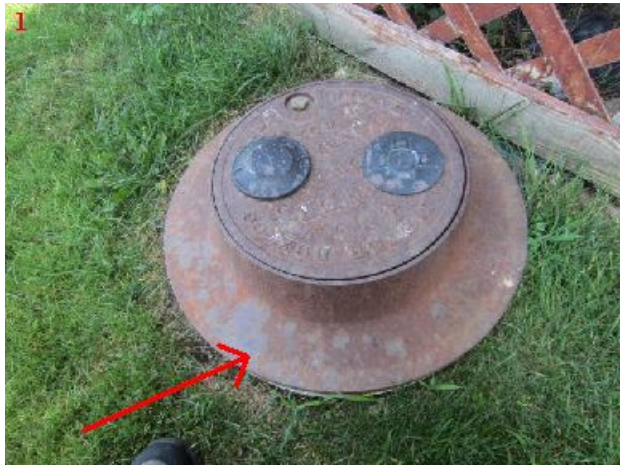
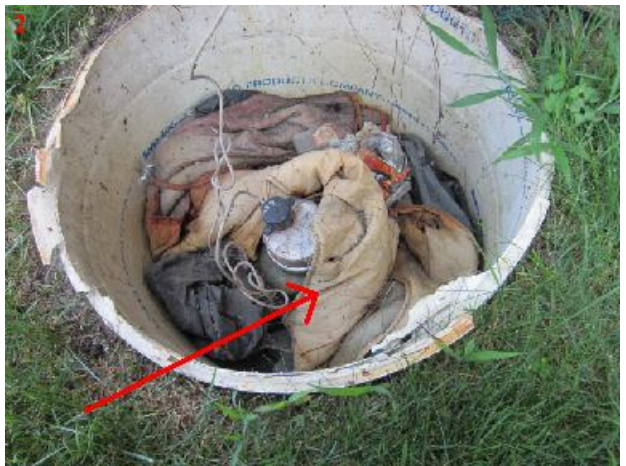
The top of the exterior water meter pit is damaged. The pit is accessible and is packed with trash. We recommend consulting the water municipality to clean out the pit and insulate the piping as needed.

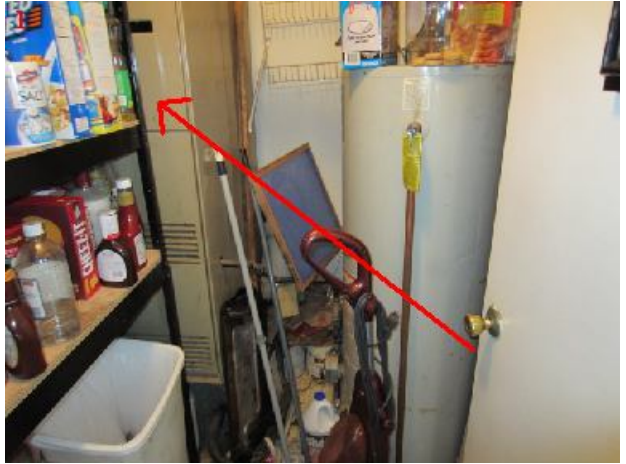
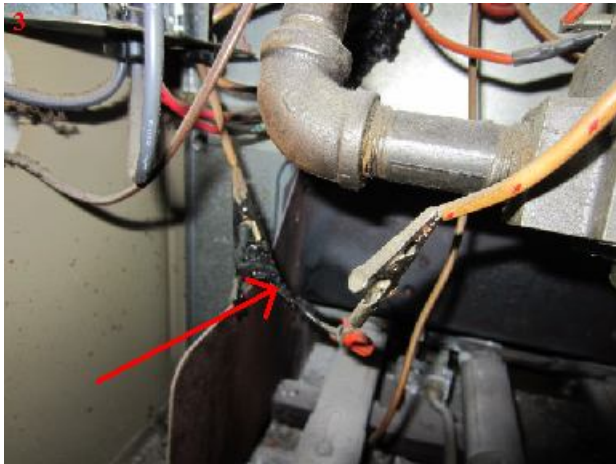
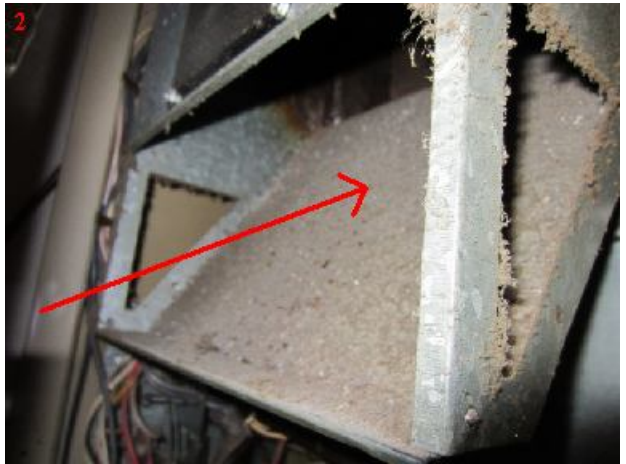
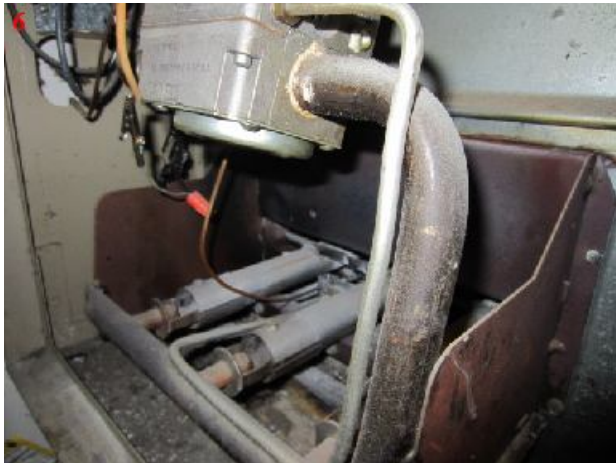
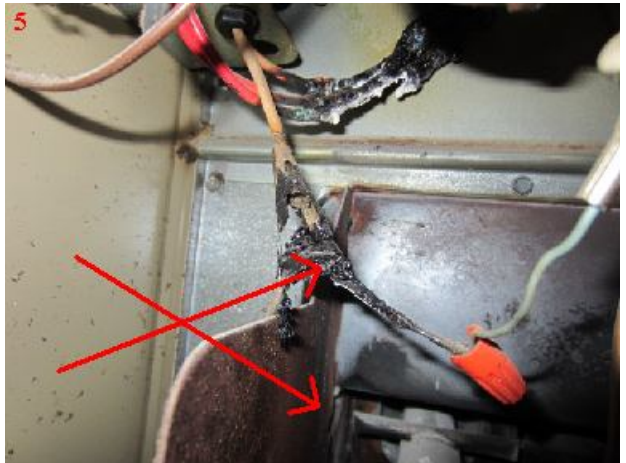
The furnace heat exchanger could not be fully inspected for cracks during the inspection. The furnace is 26 years old and past the life expectancy and does not appear to have been serviced in a while. A significant amount of rust/buildup was noted inside the burn chamber which may indicate wear inside the heat exchanger. The heat shield appears to be missing and damaged/improperly repaired wiring was noted behind the furnace cover. We recommend the furnace be certified by a licensed HVAC professional, including a full visual inspection of the heat exchanger. Expect to replace the furnace in the very near future if it passes certification.

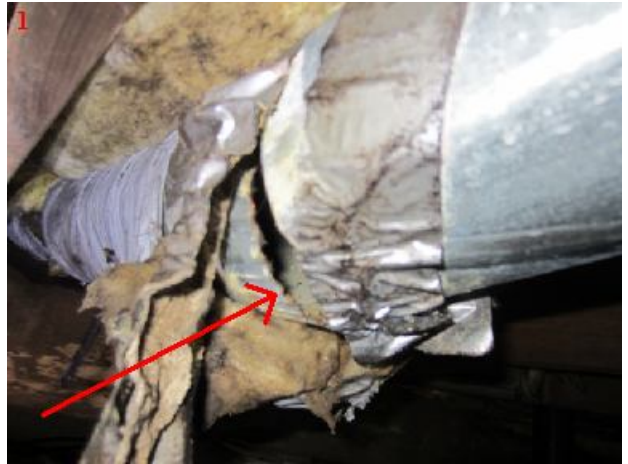
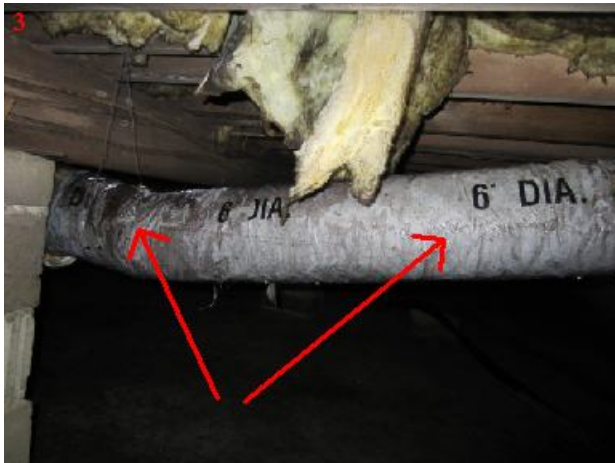
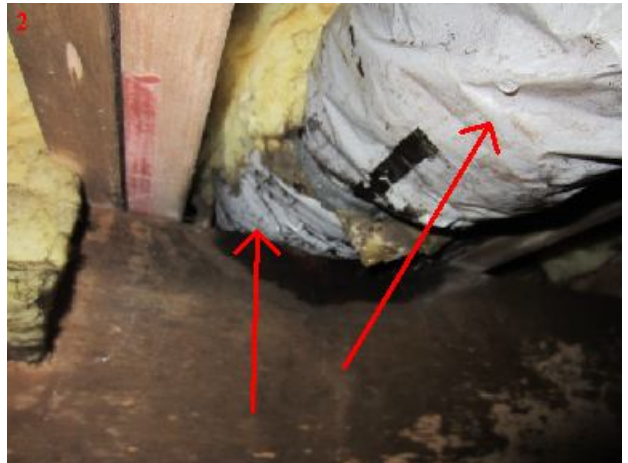
One section of the ductwork in the crawl is partially disconnected. In addition, molds and heavy condensation were noted at the insulation throughout. We recommend repairs by an HVAC professional. Consider replacing the solid ductwork with insulated flex duct.

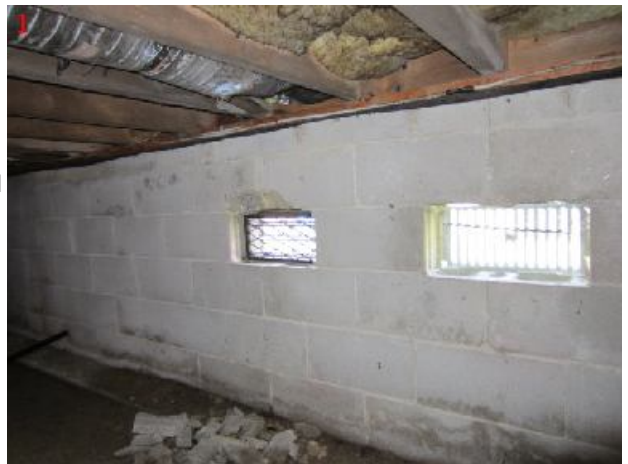
What appear to be new flood vents were installed throughout the crawl foundation. Vertical cracks were noted at the block foundation joints at the block above these vents as a result of missing lintels. Any new vent cut into the foundation block requires that you add a lintel (preferably a steel lintel) over the opening. The lintel needs to overlap the vent opening by at least 1/4 the size of the opening at each side. Lintels allow you to make openings in the foundation wall without structure degradation. We recommend consulting a licensed Contractor regarding adding lintels above all post construction crawl vents.

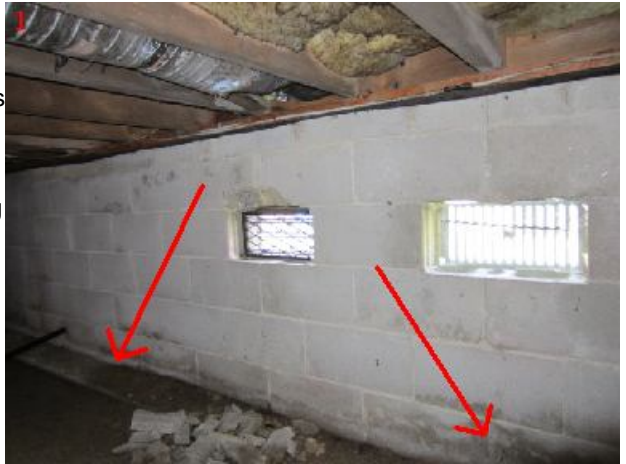
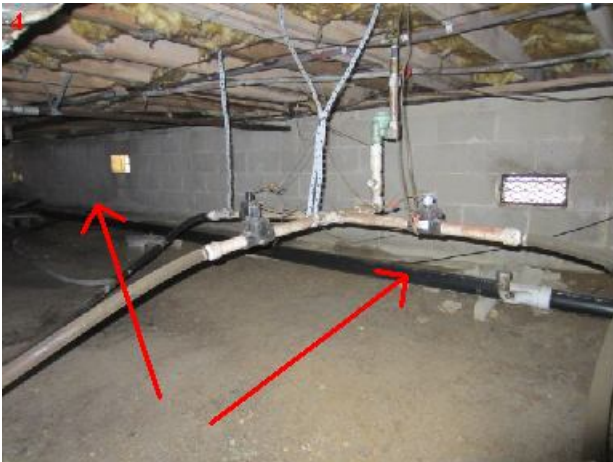
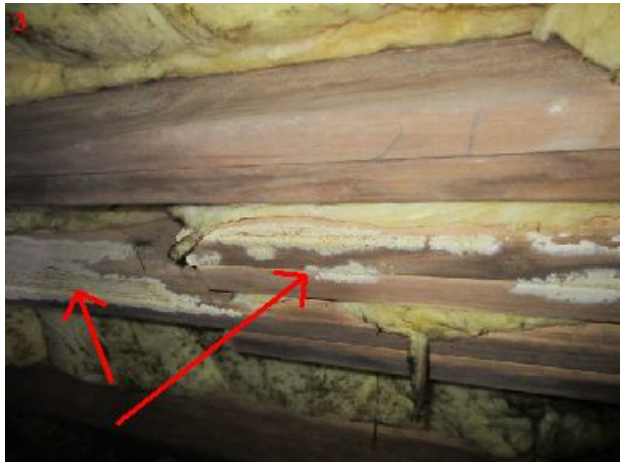
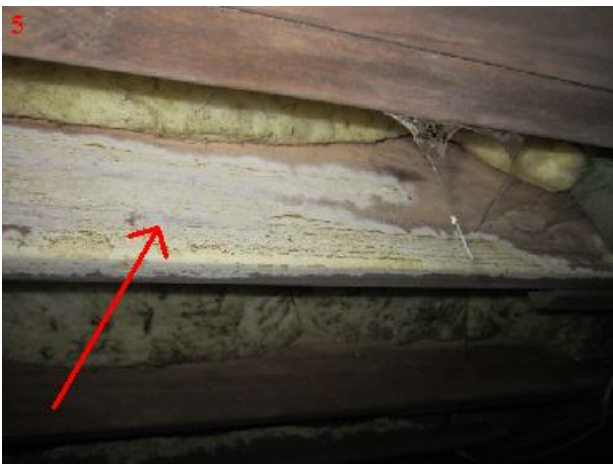
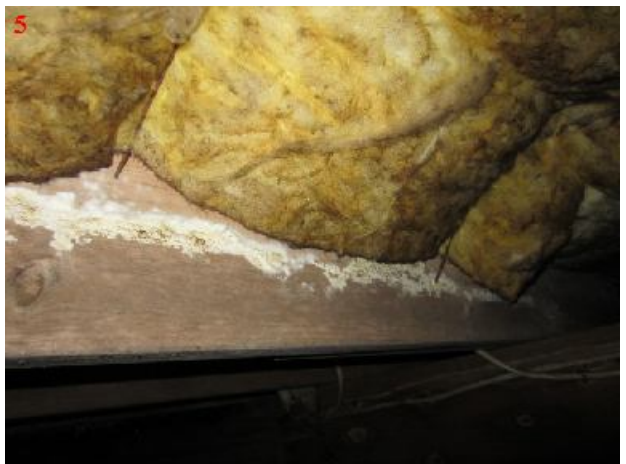
The house is built on a crawl space. Crawls in this area are prone to moisture. Moisture stains were noted up the foundation wall and block pier supports. Heavy molds were noted in spots and the insulation was saturated in spots. In addition, the condensate drain is draining several gallons of condensate to the crawl during use of the air conditioner.

We recommend consulting a wet basement/crawl specialist regarding maintaining a dry crawl. Once rendered dry, molds should be properly cleaned and sanitized by a mold professional and wet insulation should be replaced. In addition, consider the following:

- 1 - Restore the proper slope of the front gutter to correct the drainage.
- 2 - Keep crawl vents in the open position when temperatures are above freezing.
- 3 - Install a vapor barrier utilizing a minimum 6 mil poly sheeting overlapped a minimum of 12 inches.
- 4 - Maintain gutter drains a minimum of 6 feet from the foundation and restore grading where needed.

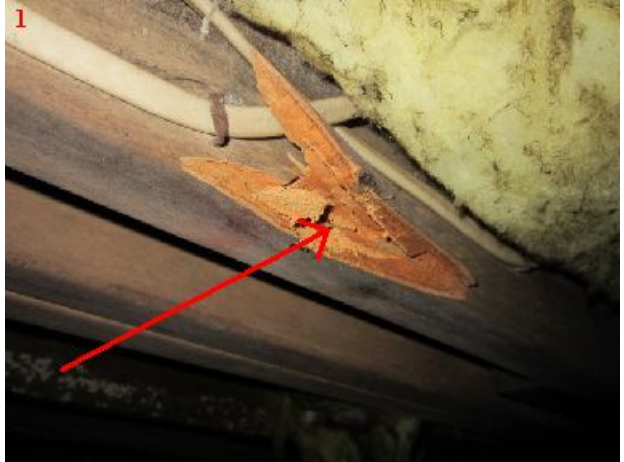
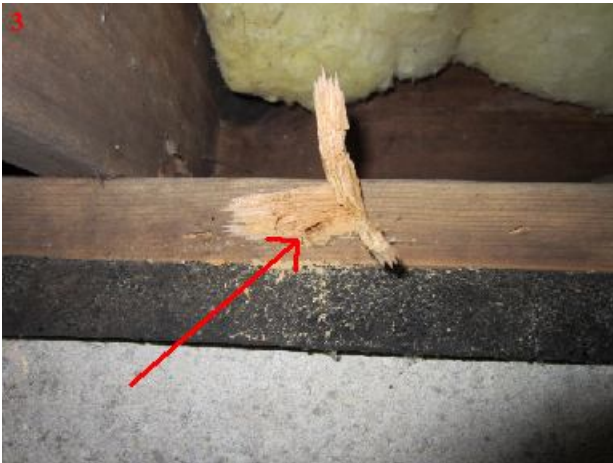
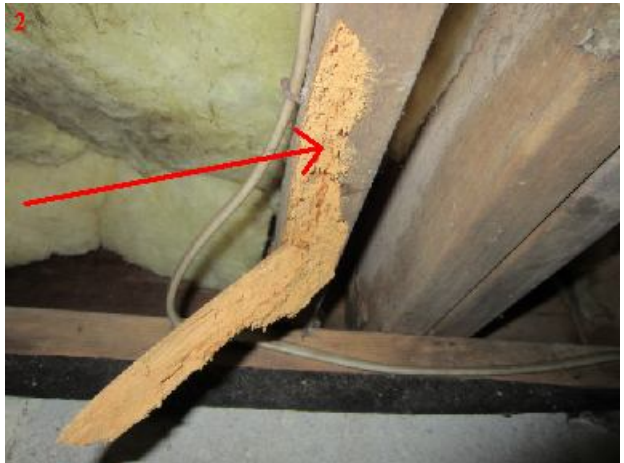
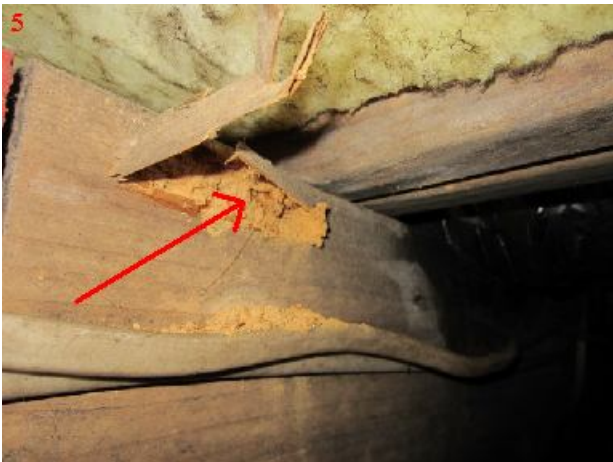
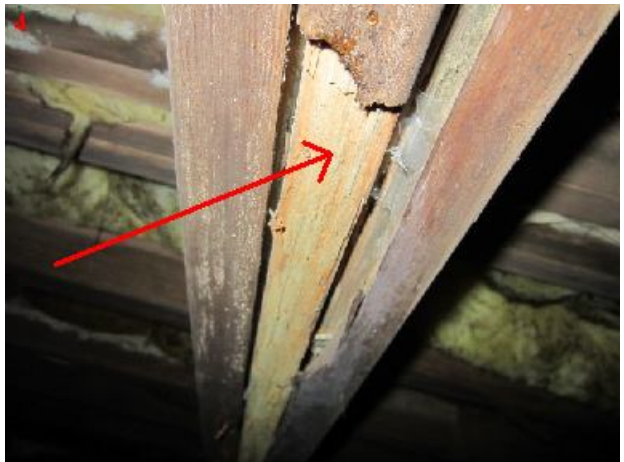
Heavy moisture was noted throughout the crawl. In addition, what appears to be wood boring insect damage was noted (possibly Powder Post Beetles). As a result of the damp conditions, we measured 30+ % moisture at the floor joists and main beam throughout a large part of the crawl. In addition, the following structural concerns were noted:

1 - The main beam is soft from the 2nd block beam support (2nd support from the rear foundation wall) to the front foundation wall of the house. The beam is sagging along the center line between the 3rd and 4th block pier and 4th and 5th block pier (counting from the rear foundation wall). The sag between the 4th and 5th block pier has split the main beam and it is starting to fail. The main beam should be evaluated by a licensed Contractor to determine proper corrective action.

2 - Soft wood was noted at the floor joists located between the 2nd block pier support and the front foundation wall (second block pier support counting from the rear foundation wall). Sections of the floor joists were so soft that our screwdriver penetrated easily into the joists with light pressure. The floor joists should be fully evaluated by a licensed Contractor to determine proper corrective action.

3 - The framing was boxed out where the HVAC duct plenum passes through the sub flooring into the crawl. The header(s) and associated framing used to box out the duct plenum is exhibiting wood rot and softening. We recommend repairs by a licensed Contractor.

Based on what we observed in the crawl space, it is likely that the majority of the main beam will have to be replaced. In addition, a large percent of the floor joists will require sistering/repair.

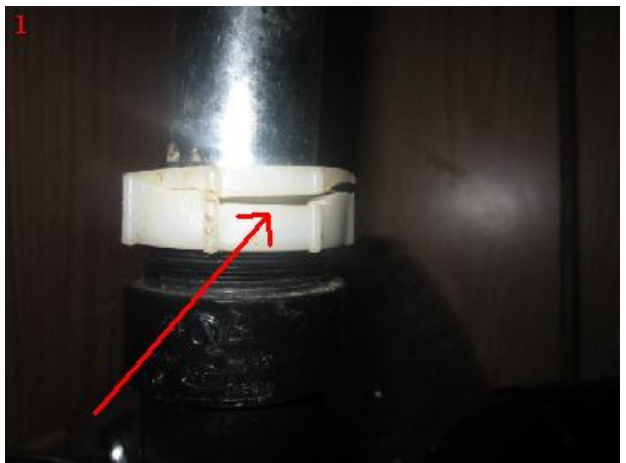
One of the kitchen sink drain fittings is split and should be replaced.

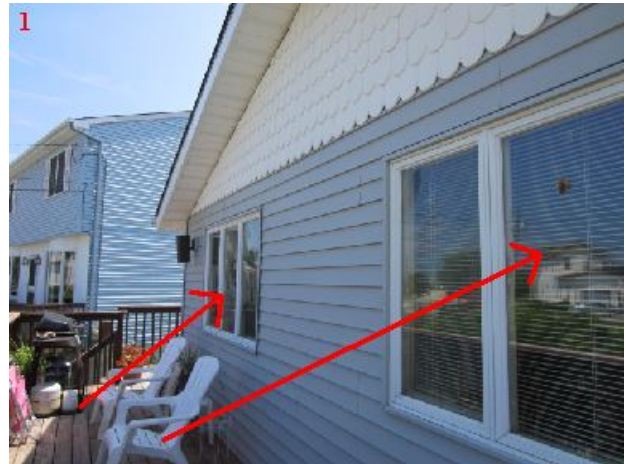
The following observations were noted with the windows that should be repaired by a window professional:

- 1 - Two of the front casement windows have cracked panes and should be repaired/replaced.
- 2 - Several of the casement window cranks are stripped and should be replaced.

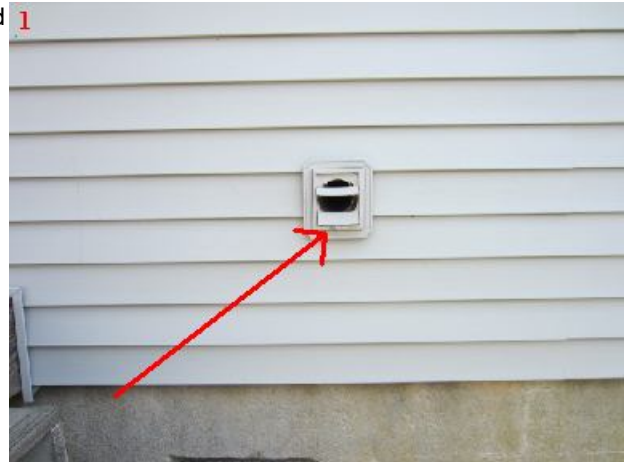
One of the exterior louver covers for an exhaust is broken and should be replaced.

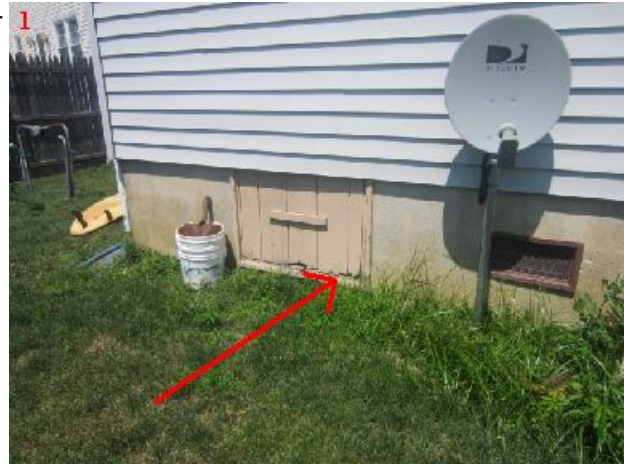
The crawl entry panel has minor damage that could allow pest entry - recommend repair/replacement of the door.

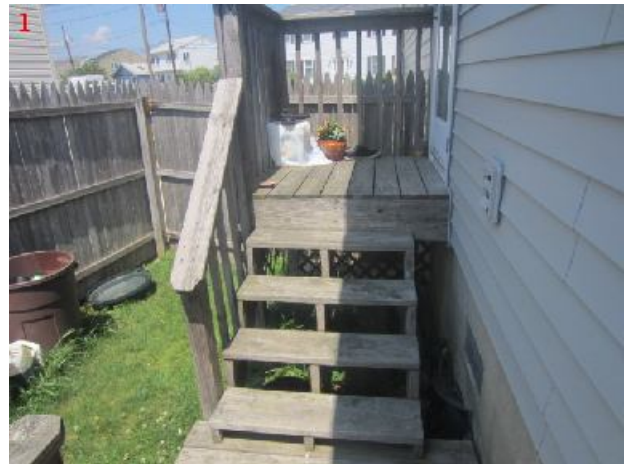
The side entry stairs (right side if looking at the front of the house) have a loose railing and are weathered, We recommend repairs for safety. Expect to replace the stairs in the not too distant future.

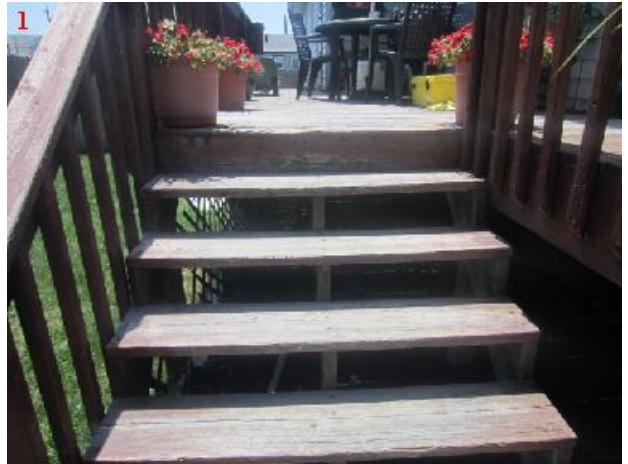
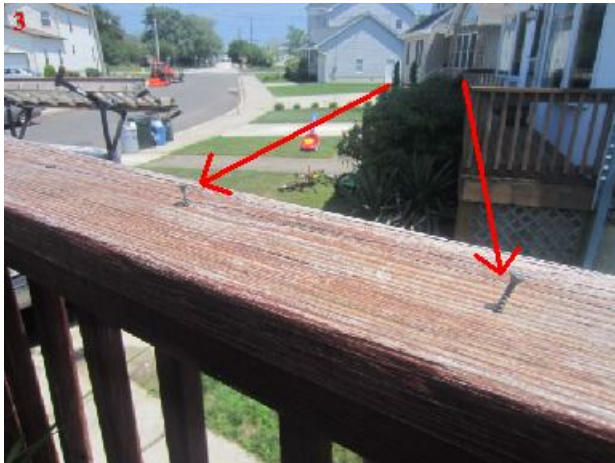
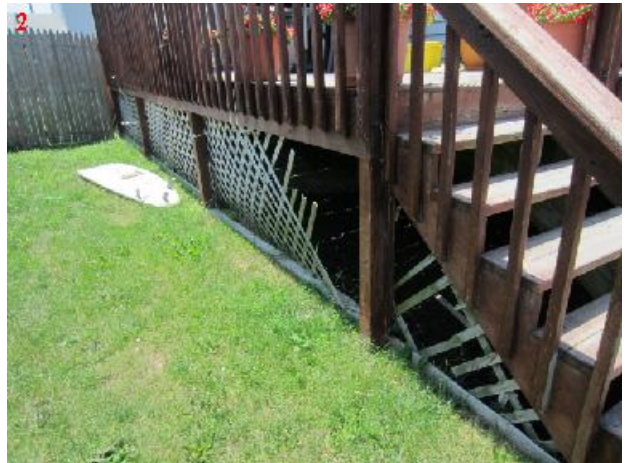
The deck appears aged and weathered and requires maintenance/repairs. In particular, dry, splintered wood was noted throughout and some raised nail/screw heads are present. As a minimum, we recommend correcting raised nail/screw heads and eliminating splintered areas. Maintenance will be required on an annual basis and, based on the current condition, replacement of the deck should be anticipated in the not too distant future.

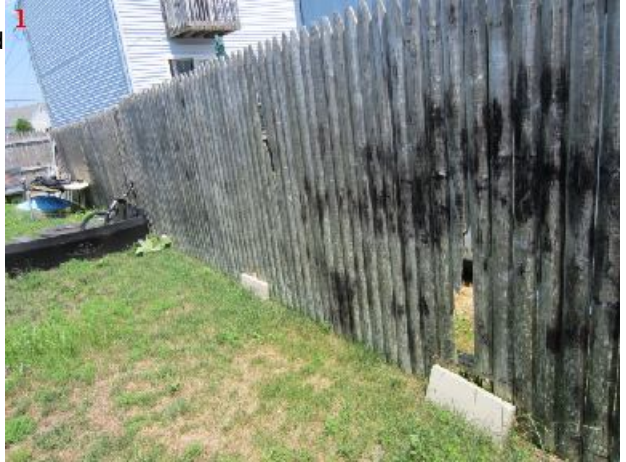
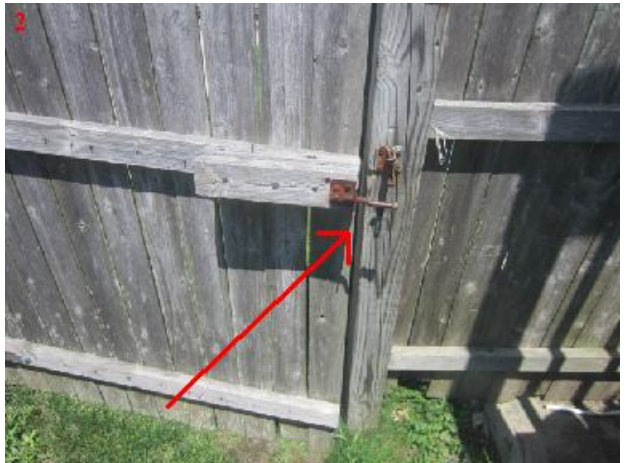
Several areas of the wood fencing, including posts, are damaged. In addition, the fence gate lock does not align properly. We recommend repairs where needed by a licensed Contractor. Expect to replace the fence in the not too distant future.

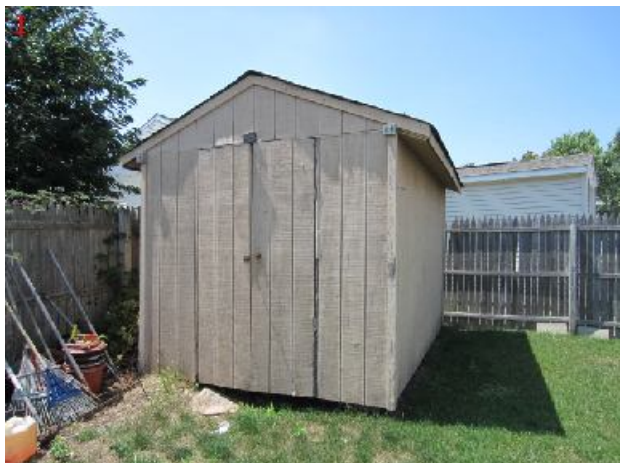
In general, the shed is weathered and extended life should not be expected.

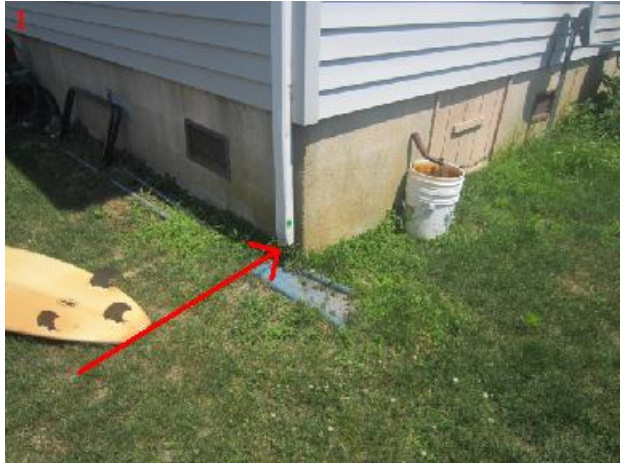
A missing downspout elbow was noted at the right rear corner of the house - recommend restoring where needed to improve drainage.

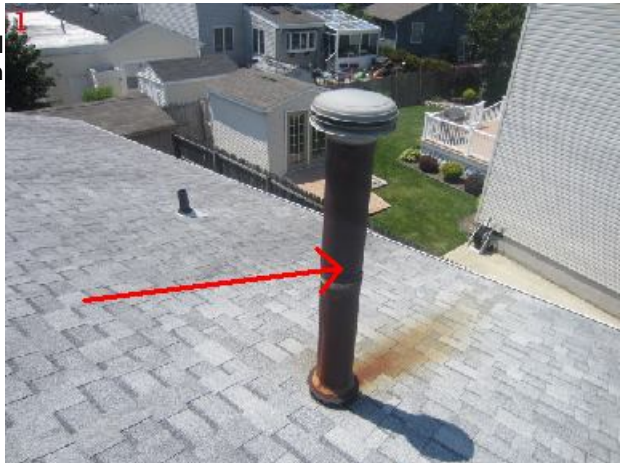
The chimney is a metal B-Vent, or double walled vent. Combustion gas is high in moisture and thus can corrode the inner lining of a B-Vent and go unnoticed. Significant rusting was noted on the outer casing of the vent. Based on this and articles written by the NFPA, we suggest getting a Level II Inspection completed on the fireplace/chimney. The inspection should be completed by someone trained in NFPA procedures. To obtain a list of certified personnel, visit the Chimney Safety Institute of America at <http://www.csia.org/homeowners/sweeps.htm>.

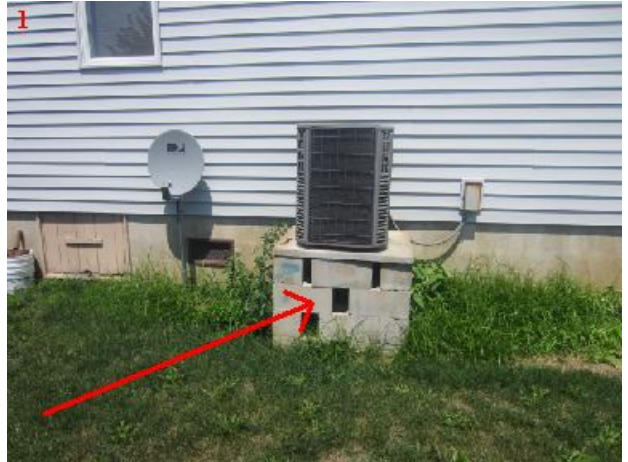
The air conditioner condenser is resting on unsecured block. We recommend the block be stabilized/grouted together to create a more secure base for the condenser.

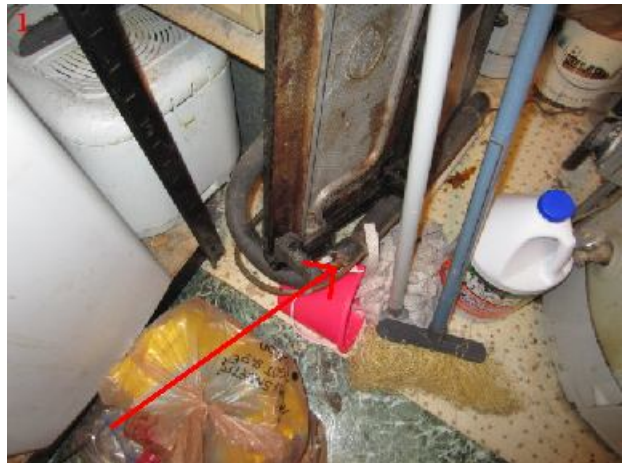
Some areas of insulation on the cooling lines are deteriorated and should be replaced.

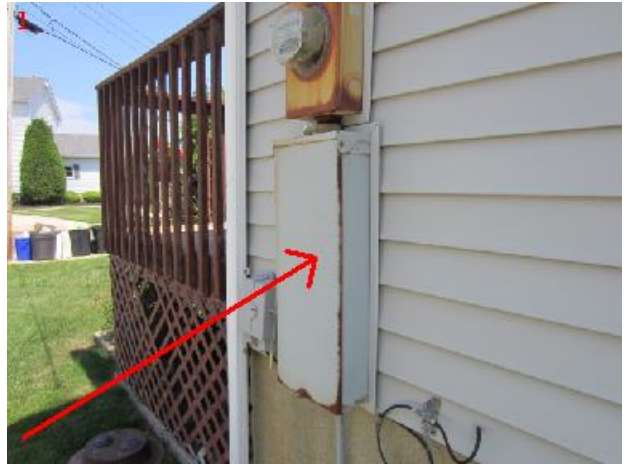
The main breaker disconnect is located outside along the side of the house. The main disconnect is unlocked and, as such, could be tripped by anyone outside the house. We recommend installing a lock at the exterior panel to help prevent outsider access.

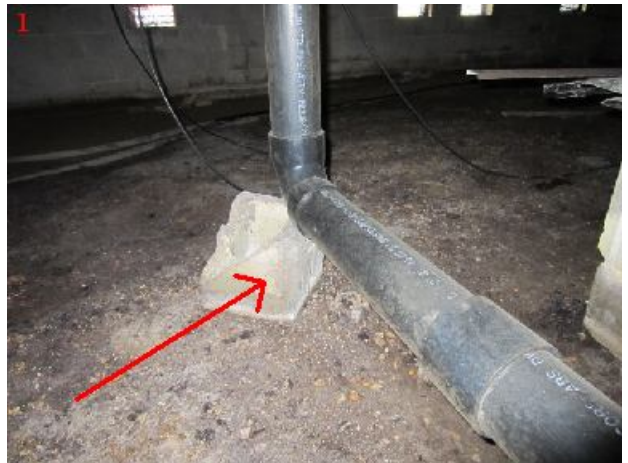
Concrete block pieces were noted supporting the plumbing waste line. We recommend consulting a licensed plumber regarding installing proper pipe hangars where needed.

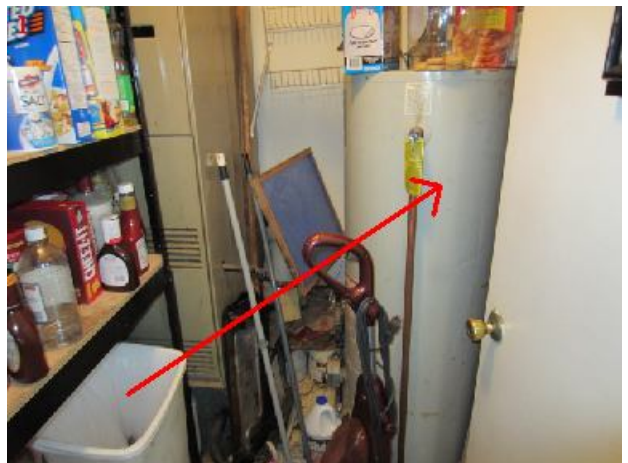
The average life expectancy for a gas water heater is 8 to 12 years. This water heater is 12 years old and at the average life expectancy. As a precaution against leakage, we recommend installing a containment pan and drip alarm around the base of the water heater. This will alarm you when the water heater begins to fail and contain any leakage to avoid water damage to surrounding areas. Based on the age and location, consider taking a proactive approach and replacing the water heater.

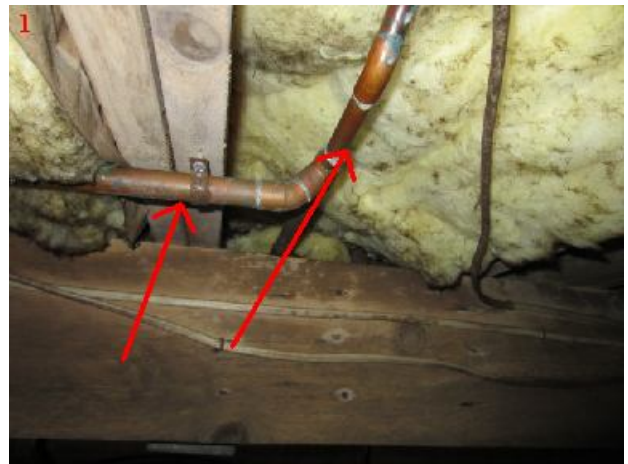
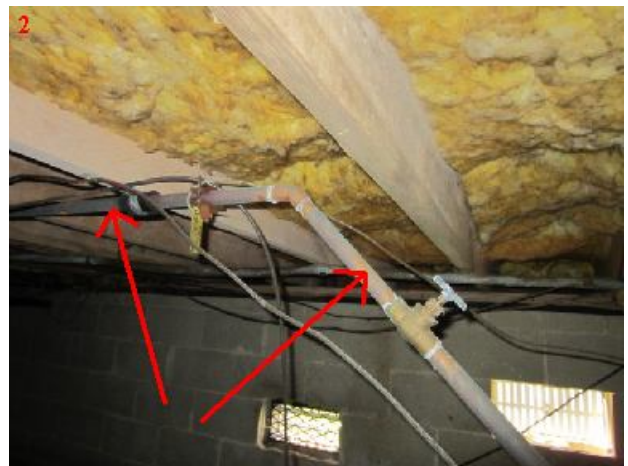
Some uninsulated piping was noted in the crawl. Piping located in a crawl is more susceptible to freezing during the winter. As such, we recommend all plumbing located in the crawl be properly insulated.

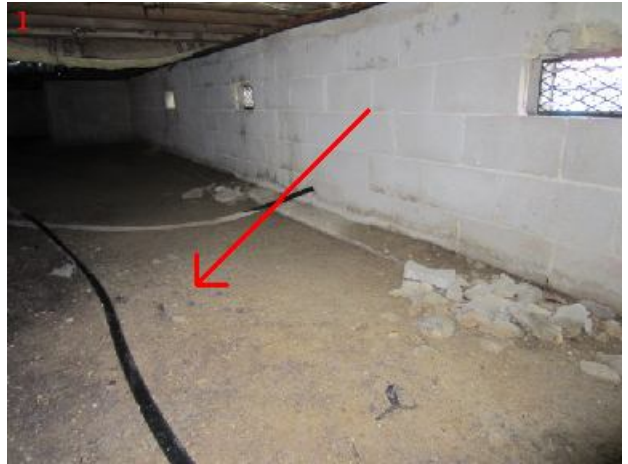
A vapor barrier (poly sheathing) is not installed. Typically, the poly sheets should be overlapped a minimum of 12 inches and the poly should be a minimum 6 mil thick. We recommend consulting a licensed Contractor to properly install a vapor barrier.

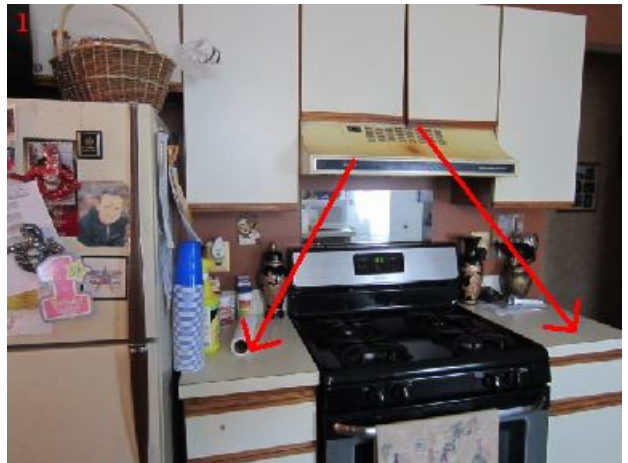
Some areas of the kitchen counters are not adequately braced/anchored down. We recommend repairs where needed to secure.

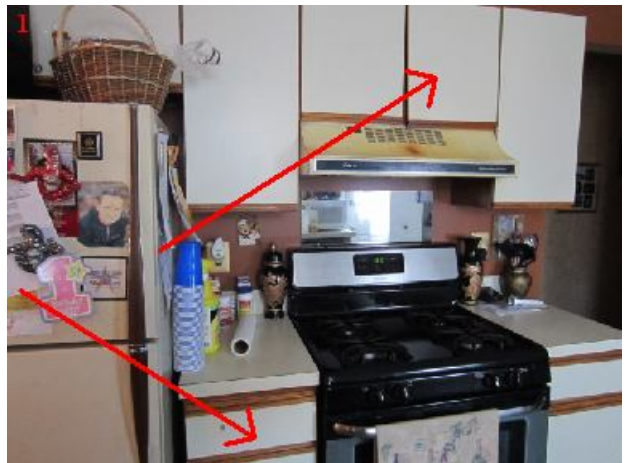
The face of one of the kitchen drawers is loose and one of the cabinet doors is off center. We recommend repairs where needed.

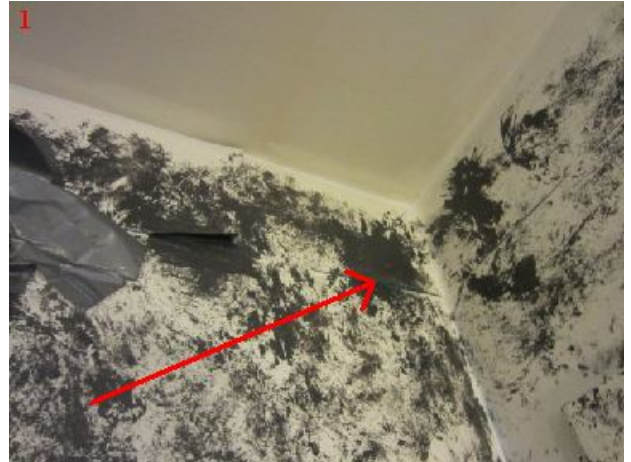
A - Common cracks were noted in the walls. Recommend repairs as needed. This will be an ongoing maintenance item.
B - Several of the walls were painted over wallpaper and/or a border. Monitor and repair as needed.

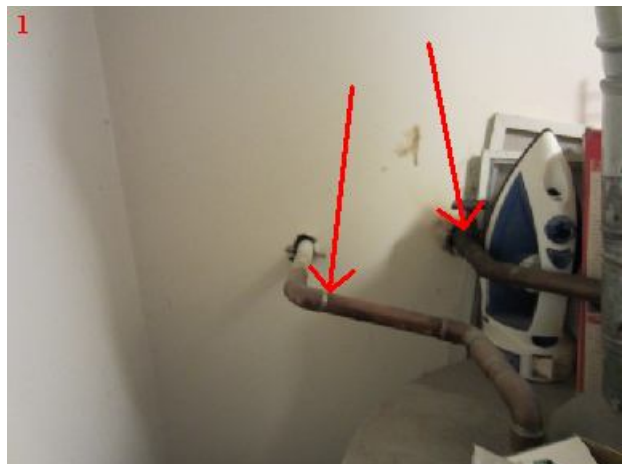
The water heater does not have a ground jumper. We recommend installation of a ground jumper for safety across the water lines to maintain a ground in case the water heater is ever removed.

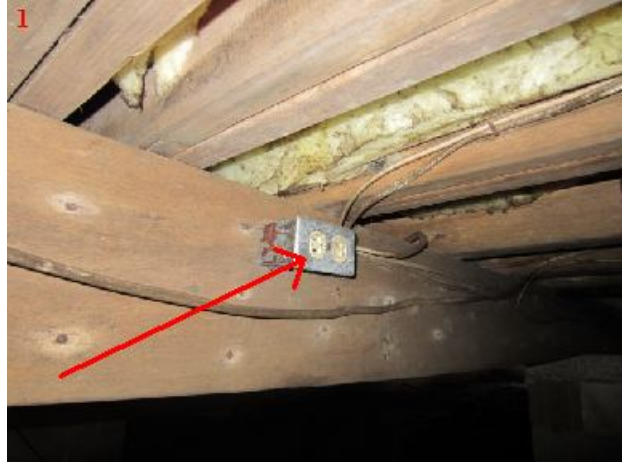
A non GFCI outlet was noted in the crawl. We recommend upgrades by a licensed electrician. Upgrades should include all exterior outlets.

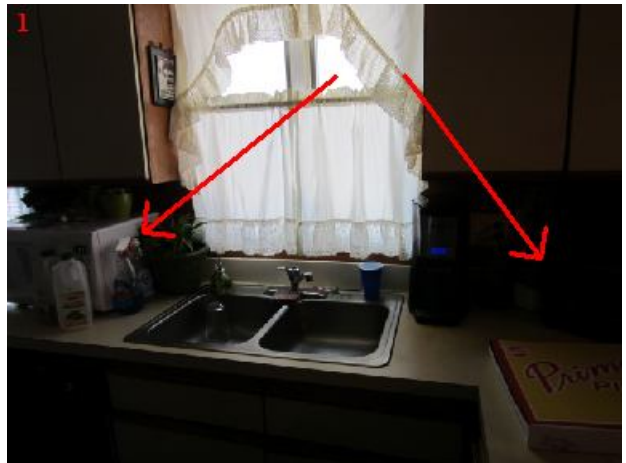
Non GFCI outlets were noted in the kitchen. We recommend consulting a licensed electrician regarding upgrading the kitchen outlets to GFCI's where needed.

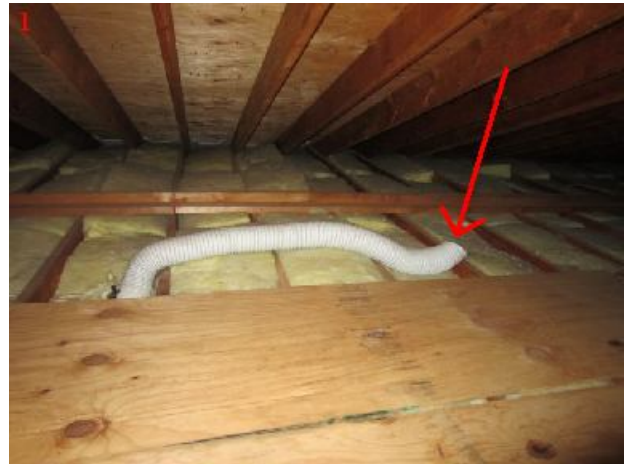
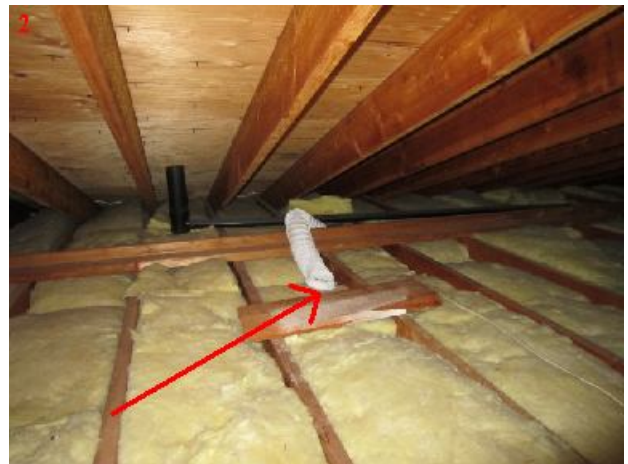
The bathroom ceiling exhaust fans terminate in the attic. This could cause condensation and moisture problems in the attic, eventually leading to possible mold issues. Recommend extending the exhausts directly out the attic.

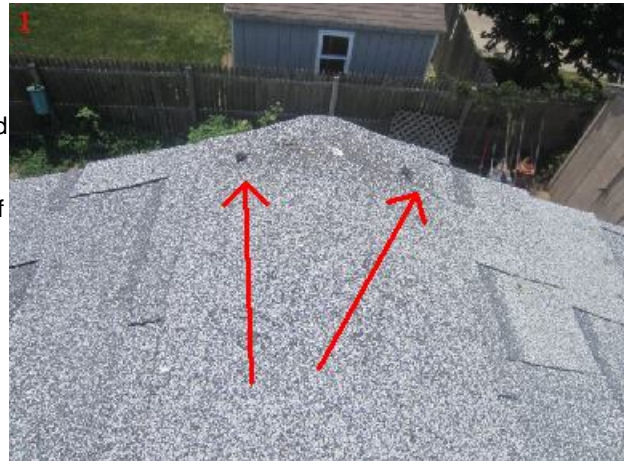
Some exposed nail heads were noted. We recommend having the roof serviced by a licensed roofer.
