Inspection Report Summary

Record 071211-1 - Report, Sample 6 McDermott Place, Brigantine, NJ 08203

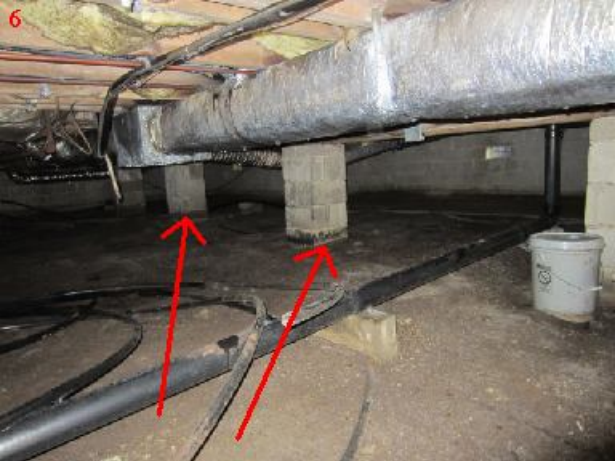
Heavy moisture was noted throughout the crawl. In addition, what appears to be wood boring insect damage was noted (possibly Powder Post Beetles). As a result of the damp conditions, we measured 30+ % moisture at the floor joists and main beam throughout a large part of the crawl. In addition, the following structural concerns were noted:

1 - The main beam is soft from the 2nd block beam support (2nd support from the rear foundation wall) to the front foundation wall of the house. The beam is sagging along the center line between the 3rd and 4th block pier and 4th and 5th block pier (counting from the rear foundation wall). The sag between the 4th and 5th block pier has split the main beam and it is starting to fail. The main beam should be evaluated by a licensed Contractor to determine proper corrective action.

2 - Soft wood was noted at the floor joists located between the 2nd block pier support and the front foundation wall (second block pier support counting from the rear foundation wall). Sections of the floor joists were so soft that our screwdriver penetrated easily into the joists with light pressure. The floor joists should be fully evaluated by a licensed Contractor to determine proper corrective action.

3 - The framing was boxed out where the HVAC duct plenum passes through the sub flooring into the crawl. The header(s) and associated framing used to box out the duct plenum is exhibiting wood rot and softening. We recommend repairs by a licensed Contractor.

Based on what we observed in the crawl space, it is likely that the majority of the main beam will have to be replaced. In addition, a large percent of the floor joists will require sistering/repair.

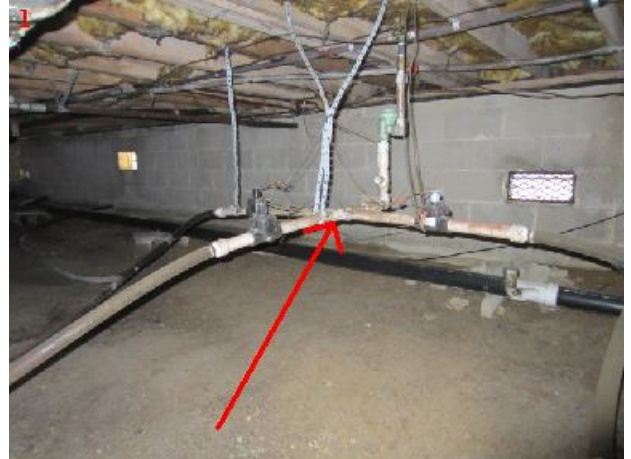
Sprinkler System

A sprinkler system is present. Consider contacting a local sprinkler company for winterizing and opening the system each year. This will help ensure that the heads are working/aligned properly in the spring and the system is sufficiently drained prior to winter.

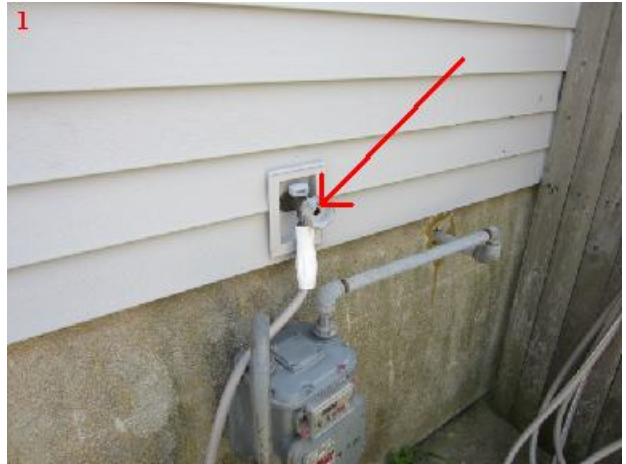
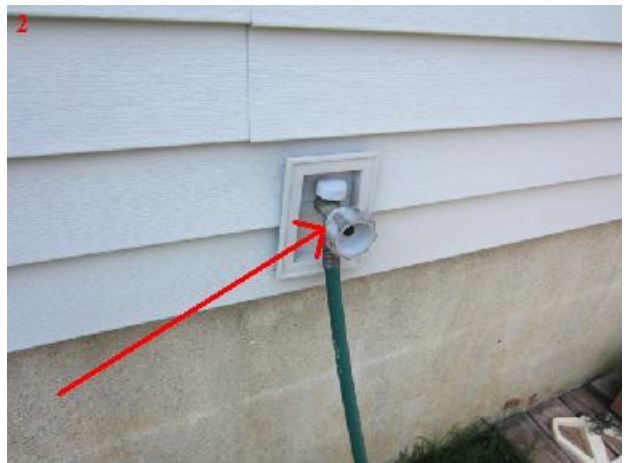
Type of Outside Spigots

Hose connections should be shut off and drained before the first freeze each year. Add this to your annual maintenance program.

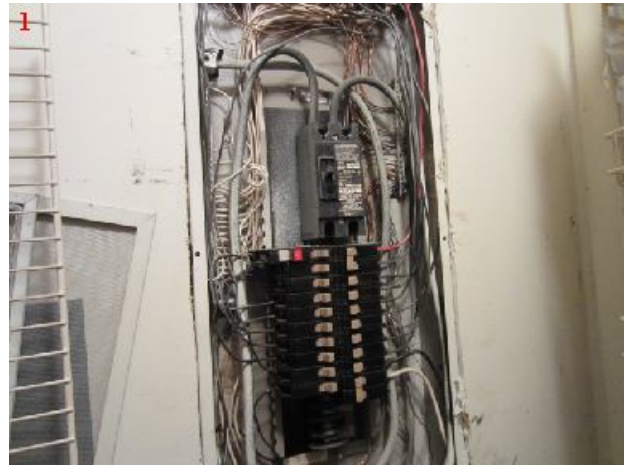
Main Panel

As part of your standard home maintenance, we recommend the main electric panel box be periodically maintained. During maintenance, the box should be cleaned, internal screws should be tightened, the mains should be regreased, and the weather seal/packing should be restored. Panel boxes should be serviced every 5 to 7 years or as needed.

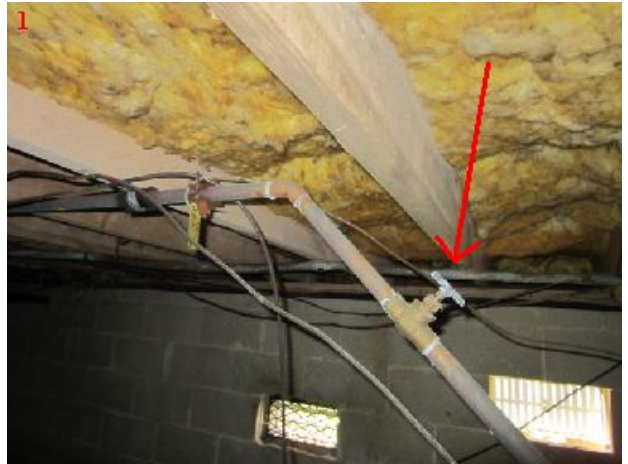
Main Supply Type

The main water shut off valve is located in the crawl. This valve, when turned clockwise, will shut down the water throughout the house.

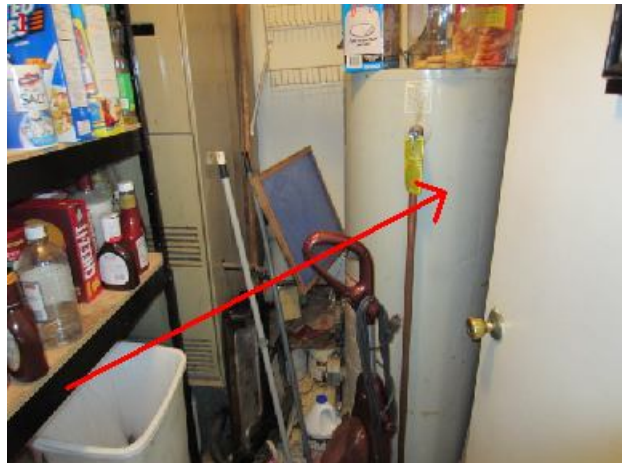
WATER HEATER No. 1

Water heaters require maintenance on an annual basis. Consult the manufacturer's guidance for the recommended maintenance procedures. Maintenance can include:

- 1 - draining and cleaning the tank
- 2 - changing the anode rod
- 3 - replacing a heating element (electric water heaters only)
- 4 - testing the temperature/pressure relief valve (only test if the proper extension pipe is attached)
- 5 - adjusting the water heater thermostat

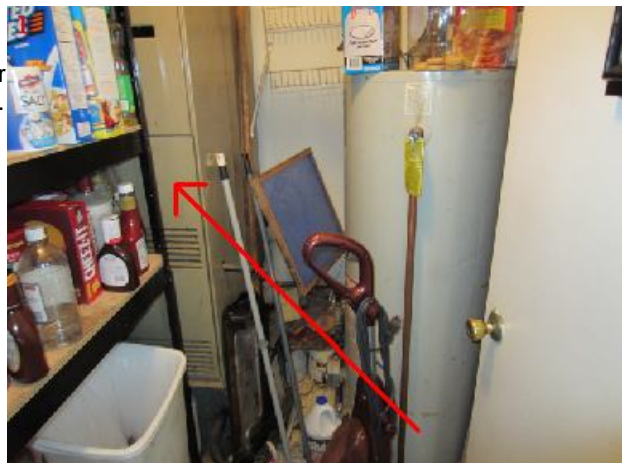
FURNACE/AIR CONDITIONER No. 1

If the heater is not properly cleaned and maintained, the life expectancy may be reduced. Upon occupancy, we recommend obtaining an annual service contract from either the local gas supplier or a licensed HVAC professional to help prolong the life of the heater.

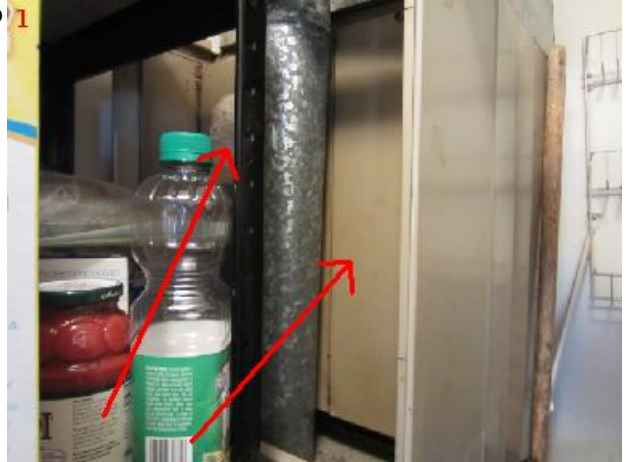
Filter System

The air filter installed is disposable and should be replaced every 1 to 3 months depending on use. When replacing, make sure to install the filter properly by aligning the filter directional arrow with the direction of the air flow (remember that the air flows down the return air duct towards the heater).
